# PEZZIMENTI TUNNELBORE

**MOUNT OUSLEY**

**X3 CULVERTS INSTALLED UNDER MOTORWAY**

## Culvert - New Installation - Open Face Shield

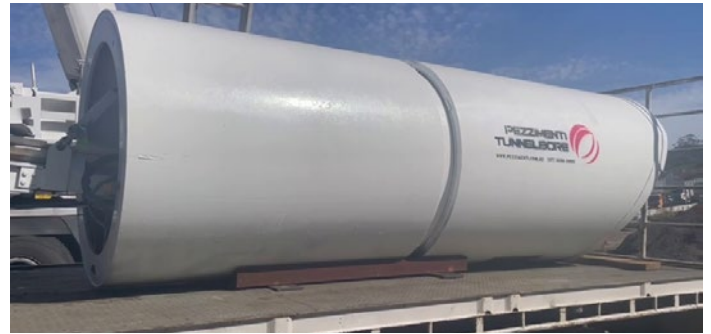
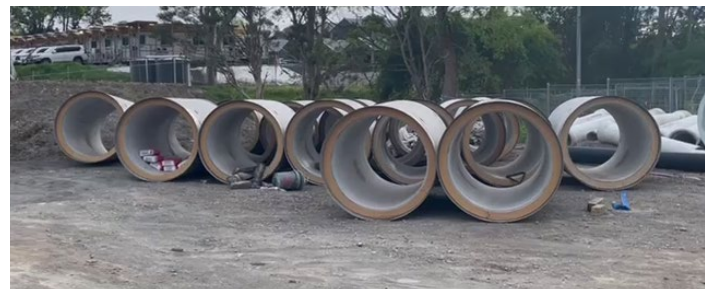
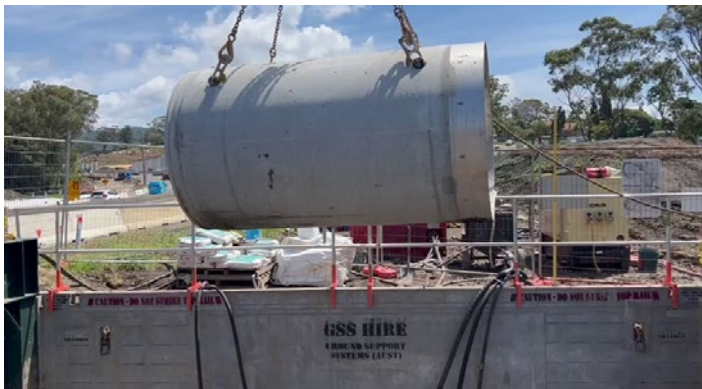
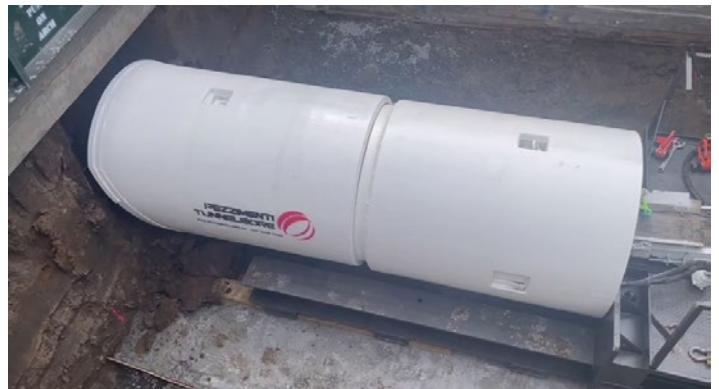
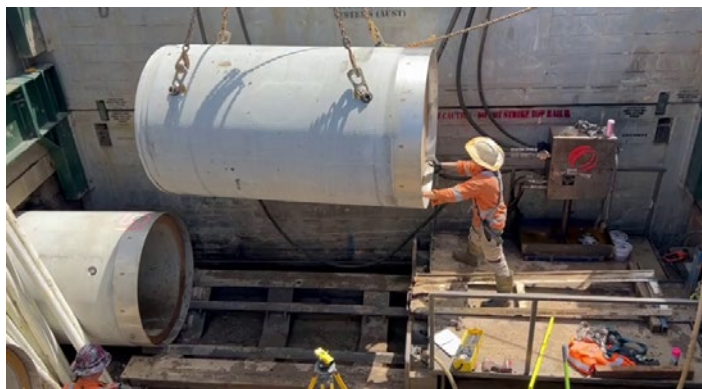
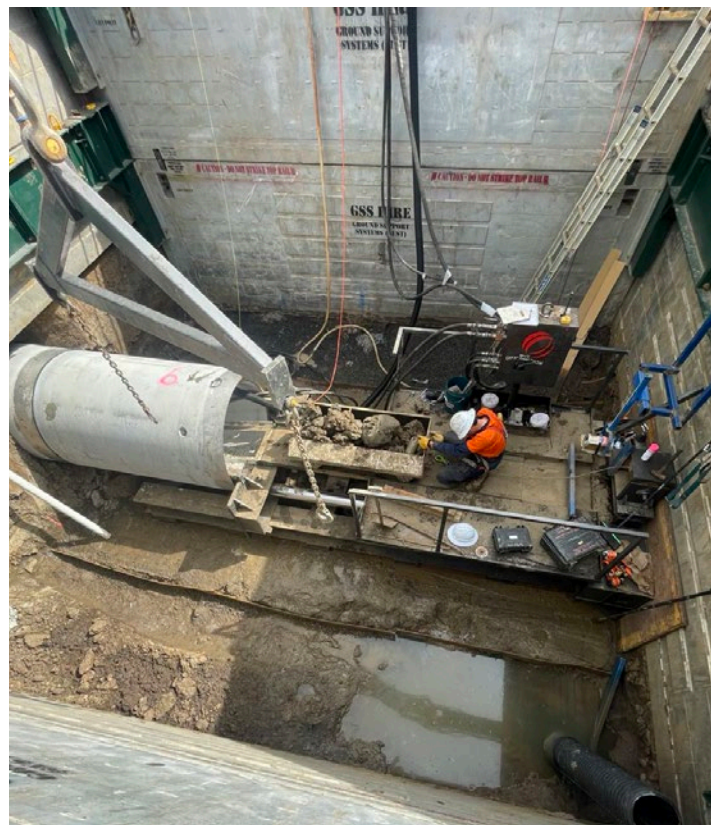
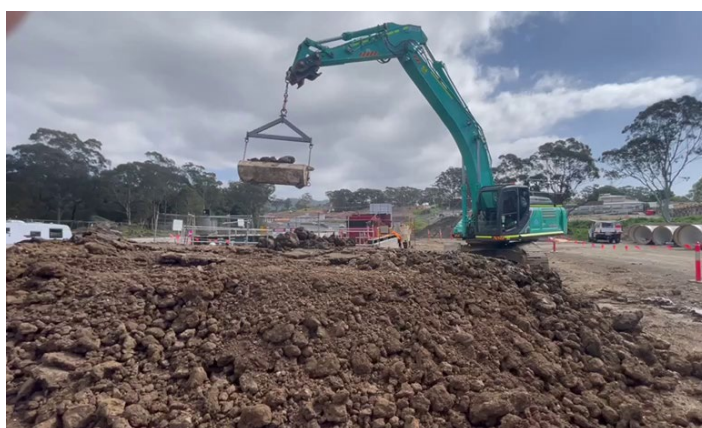
Open Face Pipe Jacking requires an operator to enter a steerable shield and excavate with a mechanical digger arm. The material is pulled onto a conveyor belt which then loads a wheeled skip bin. The wheeled bin is then winched back to the shaft, lifted out by an excavator and emptied on site. At no point is the ground unsupported due to the design and shape of the shield.

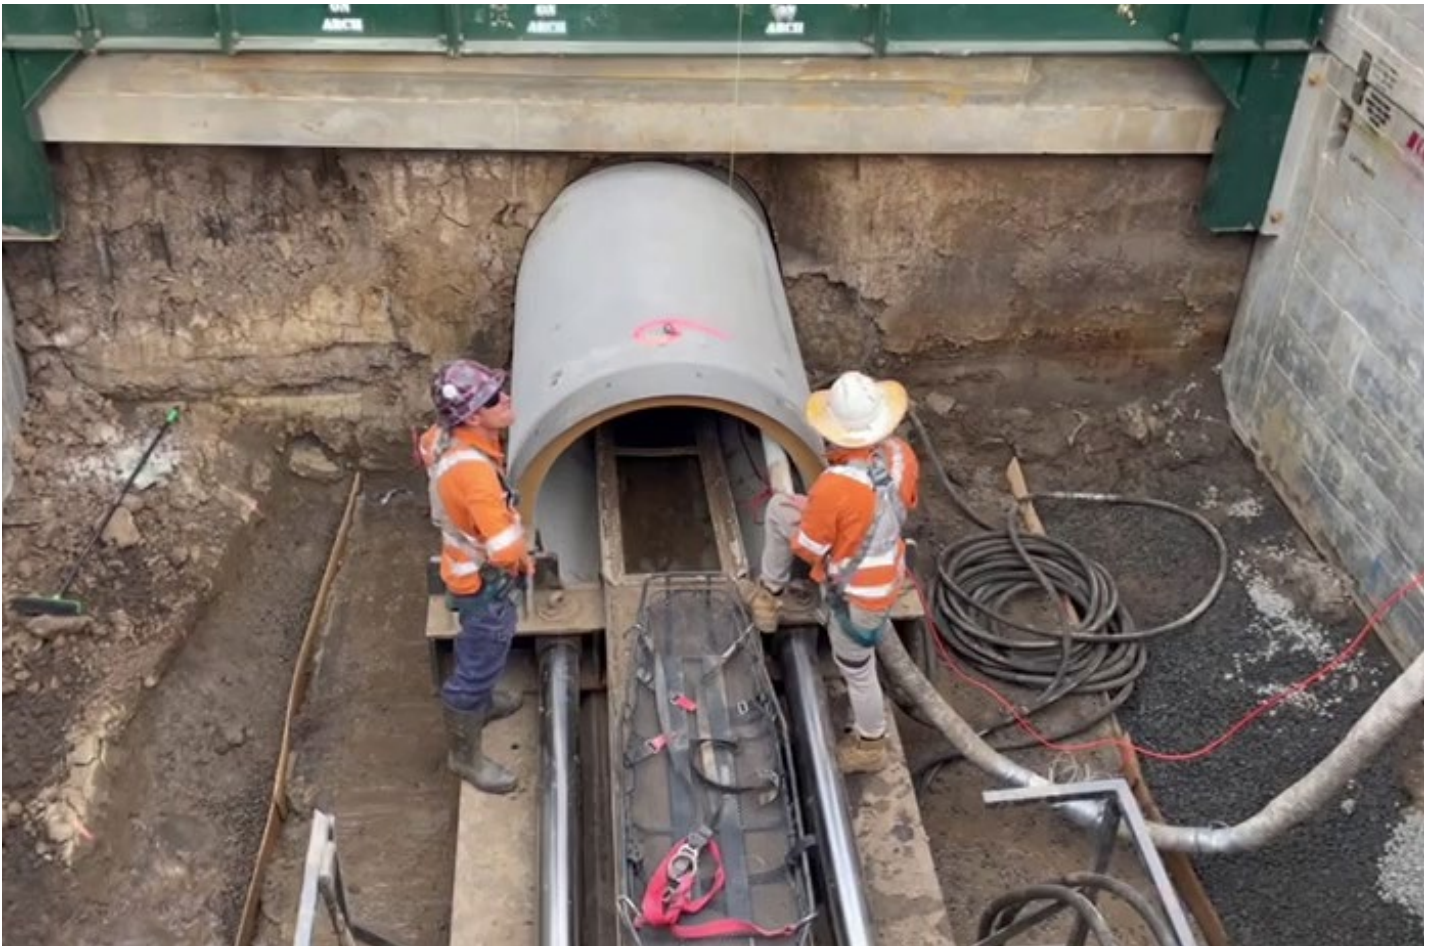
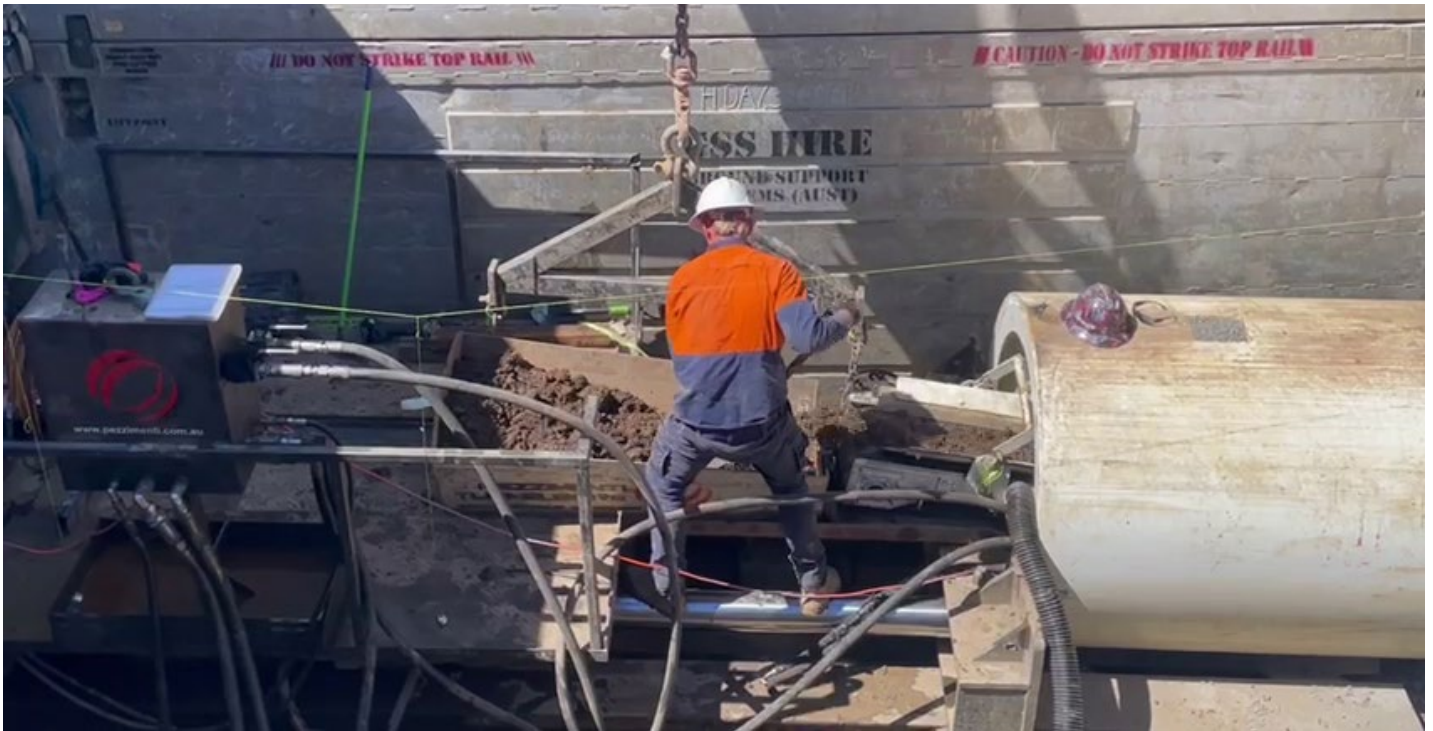
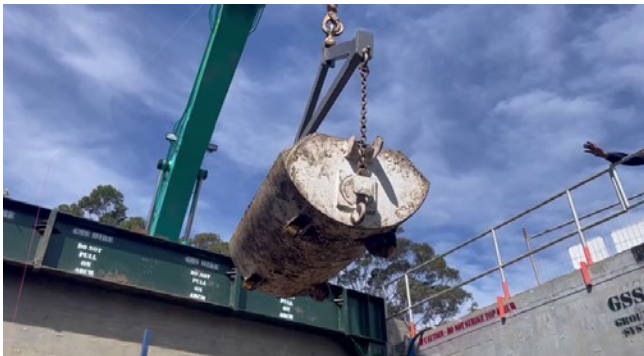
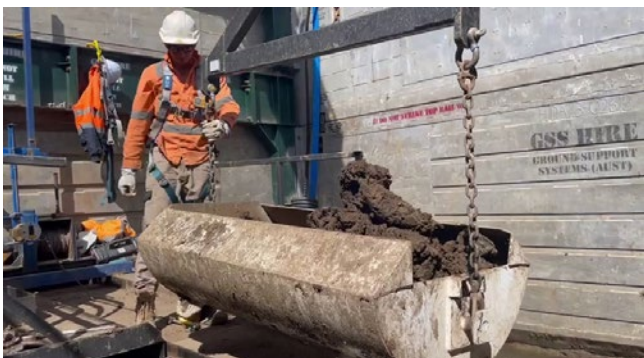
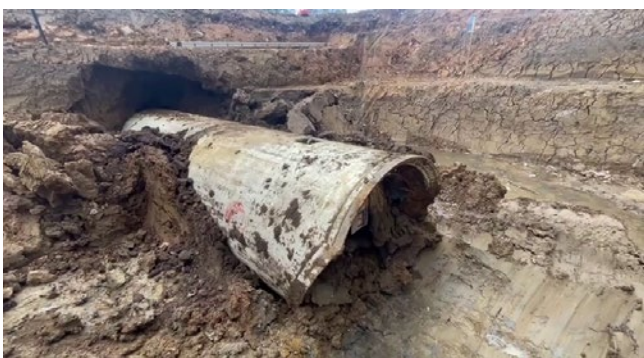
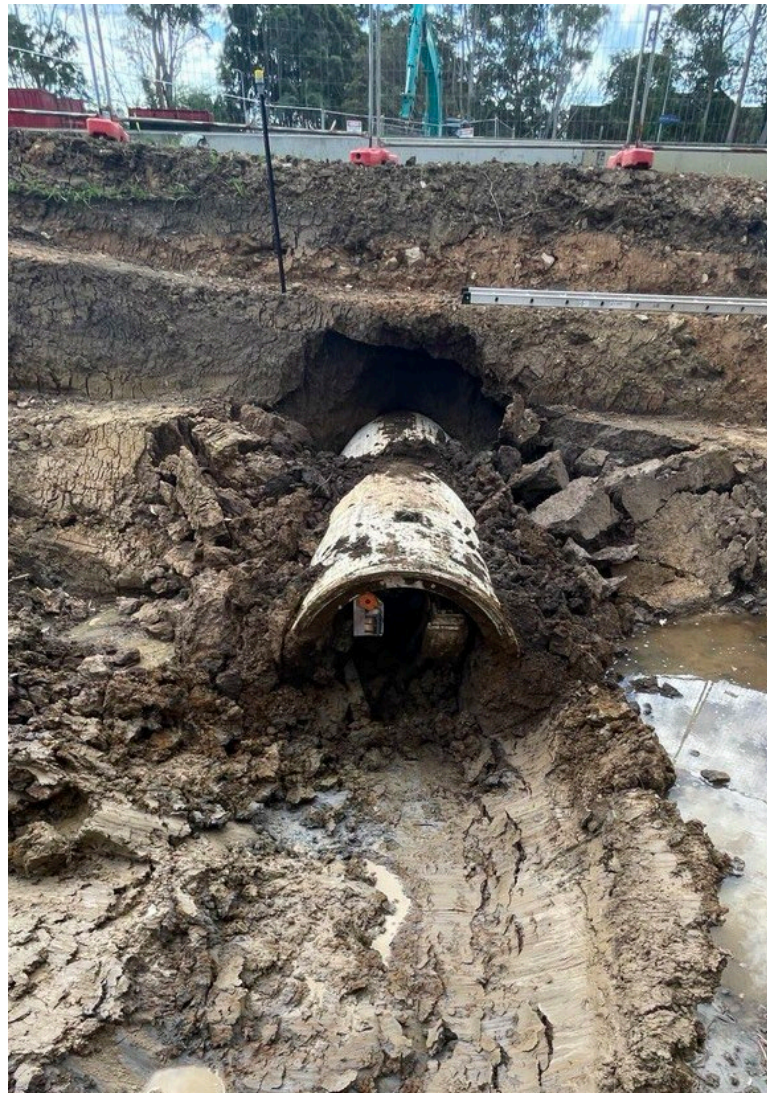
## Tunnel 1:

Progress was steady at about 3m per day though significantly slowed by the high plasticity clay for the first 7 days. The high plasticity clay always slows down any type of excavation and this was certainly the case on this job. The 'sticky' clay was primarily at the top of the tunnel and probably contributed to the very low settlement recorded.

Progress was temporarily halted at the 23m (out of 36m) mark when a layer of slag (assumed to have come from the nearby steelworks) was encountered at the top of the tunnel. Minor water inflow also began at the same time. Jack hammering of the slag/cement by hand proved slow as the material punctured easily but did not break off. As the obstruction was just outside the fog line of the Motorway, a decision was made to open the road on a night shift, exhume the cement/slag and replace it with a weak stabilised sand. The project delay happened around the October Long Weekend so the interstate crew headed home while the night works were completed by FH.

It is rare that a latent condition requires a dig down as was required on this job. The difficulty to hand-excavate in the slag/cement and its relatively shallow depth meant an intervention by dig down was the quickest and most economical option. The annular space around the pipes was injected with bentonite to prevent the pipes from being frozen in while jacking was delayed.

Ground stabilisation was completed in 9 days and work recommenced. The axial load on restart was initially high at 108T until the seal was broken after which it returned to 72 T. The remaining 13m was tunnelled to the 36m mark in another 4.5 days. The annular overcut was grouted via the grout ports cast into the pipes after the pipes were pushed into their final position.

Settlement of the motorway was precisely monitored but only 'insignificant' settlement occurred, A maximum settlement of 5mm was recorded with the vast majority of readings being 2mm or less.

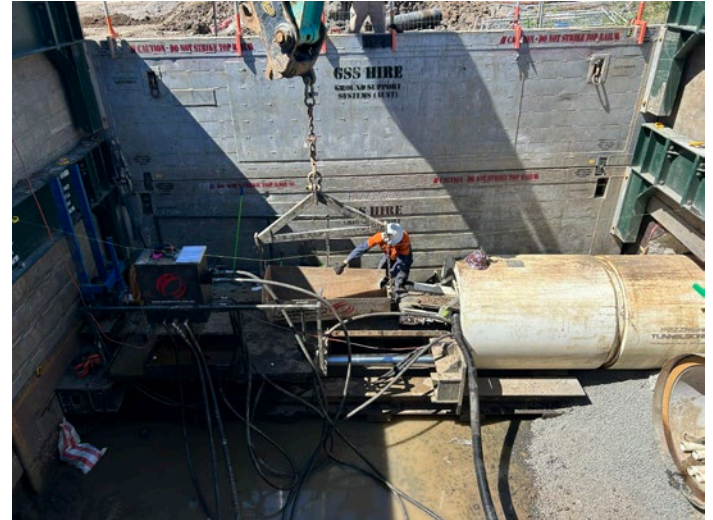
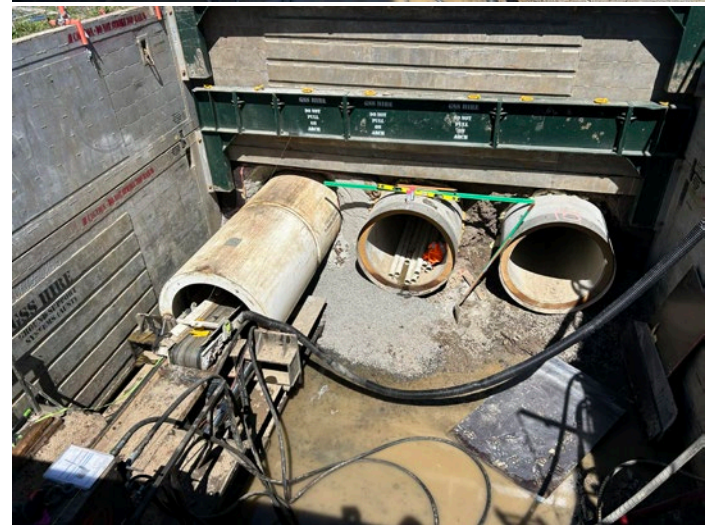
## Tunnel No 2:

Tunnel 2 was on the north side of Tunnel 1. The transfer of the equipment to Tunnel 2 took 4 days. Pipe jacking took 9 days working (with 2 RDOs on top of that) to complete the 36m drive an average of 4m per day. Jacking loads were again very low at 60T, settlement was again insignificant with a max recorded of 5mm and the accuracy achieved was within 1mm vertically and 3mm horizontally. The high plasticity clay was again encountered in the upper portion of the tunnel. This slowed progress due to the material wanting to 'ball up' into soccer ball size pieces and sticking to everything it touched- the digger arm blade, the conveyor, the skip bin. Emptying the skip bin was time consuming. Again the annular over cut was grouted after the shield was retrieved from the exit pit and the pipes pushed to their rest position.

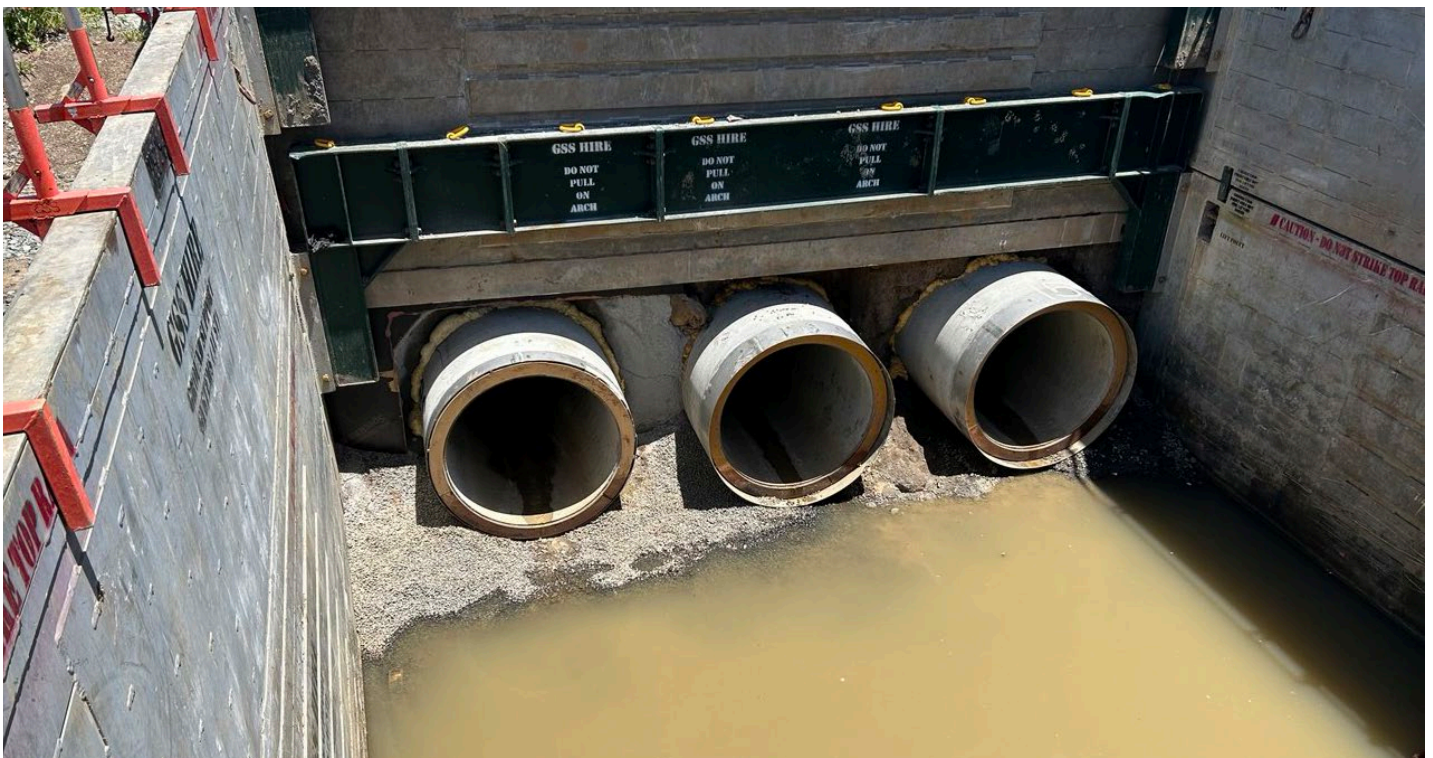
## Tunnel 3:

Tunnel 3 was commenced in early November 2025. The tunnel was excavated in 9 working days i.e. 4m/day average. Axial loads were again low at 60T, settlement was again insignificant, accuracy was within 3mm in both directions and the high plasticity clay again reared its ugly head to slow progress.
